Investigation of metallic contaminations found
in vector- and mRNA-based
COVID-19-”vaccines”
- Preliminary results -

March 2022

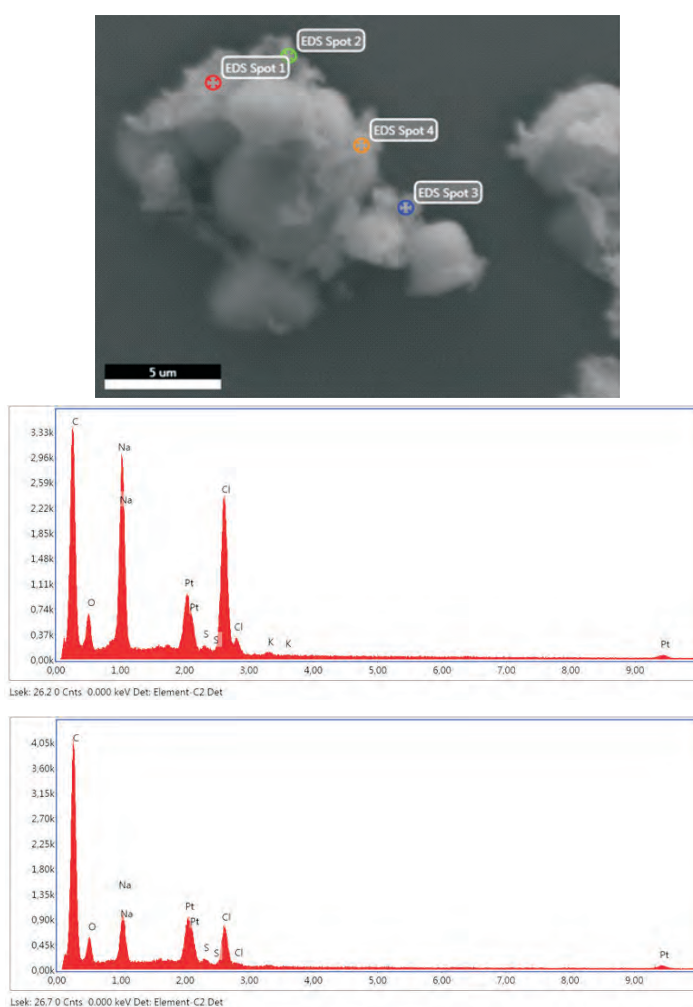
This sample was prepared in another lab for SEM/EDX-experiments. In this case the sample holder was covered with a thin platinum (Pt) film prior to the SEM/EDX measurements to ensure the required electrical conductivity. Figure 2 displays a typical SEM image of the protein component of Lubecavax. The EDX-point spectra show a spot with more Na and chlorine (Cl) (likely NaCl) (spot1) and a spot with more organic components (spot4), Except low amounts of S and K no other contaminations are found.

Figure 2: Top: SEM image of the dried protein component of Lubecavax-vaccine. Center and bottom: EDX point spectra of dried vaccine (spots 1 and 4). Note that Pt does not belong to the sample probed by EDX due to the sample preparation described above.

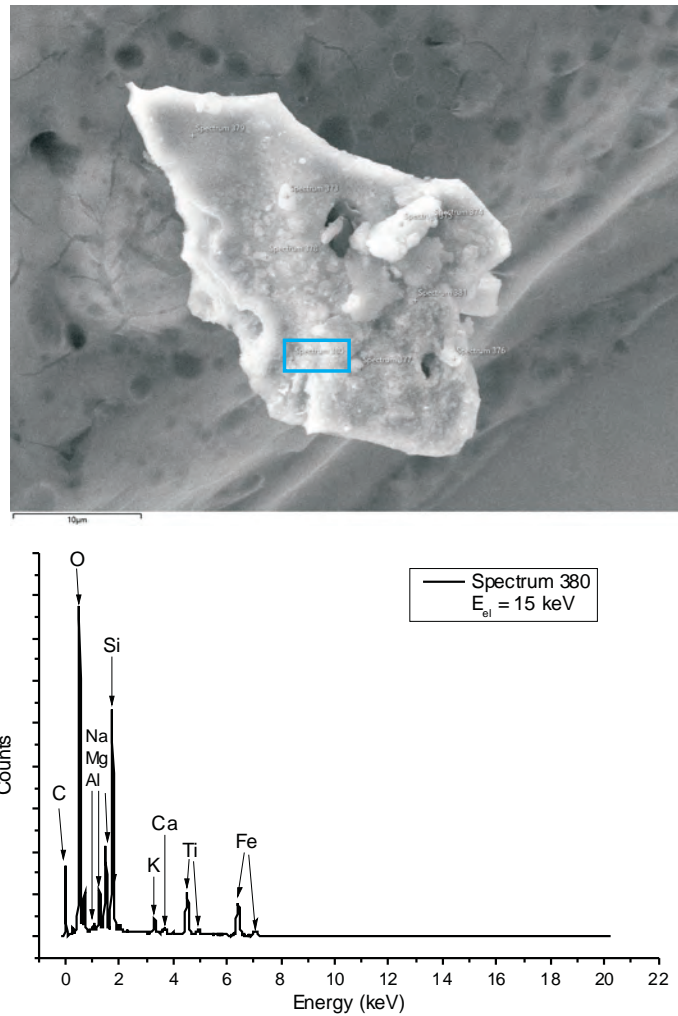
This sample was prepared from a vial of the same lot but at another lab opening the vial and then preparing the sample as described in section 2. Figure 17 shows a SEM image of a contamination comprising significant amounts of Si, Ti, and Fe. Traces of Na, Mg, Al, K, and Ca are also detected.

Figure 17: Top: SEM image of a particle of 15-20 μm size. Bottom: EDX point spectrum of this particle (site 380), marked by a blue frame. Note that Ir does not belong to the sample probed by EDX due to the sample preparation described in 2.
